# MARYLAND HISTORICAL TRUST NR-ELIGIBILITY REVIEW FORM

Property Name: Moore's Orchard Inventory Number: BA-2142

Address: 5228 East Joppa Road, Perry Hall, Baltimore County, Maryland

Project: Ryland Homes Development Agency: COE Wetlands Permit

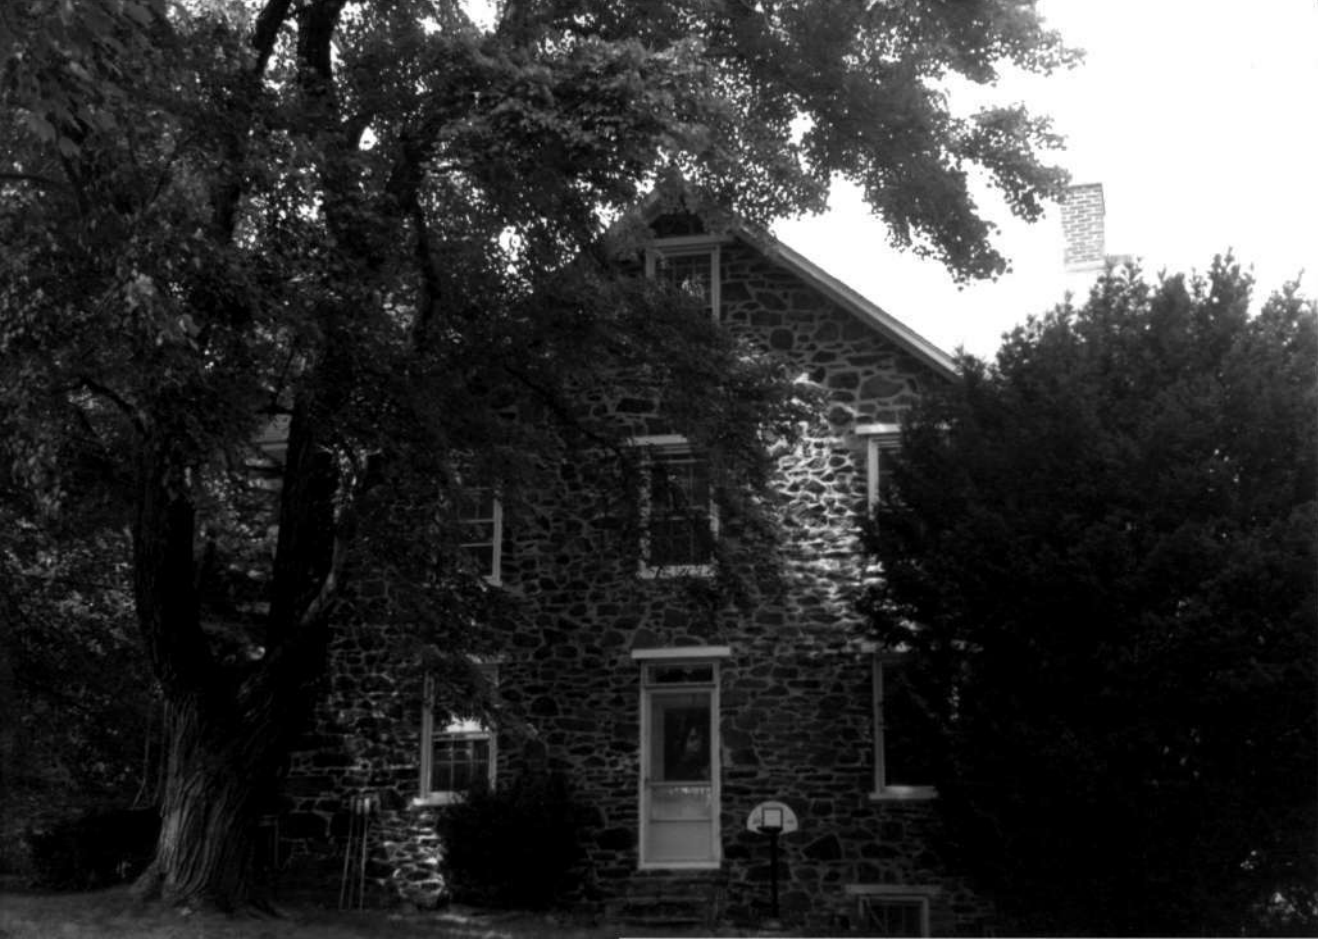
#1 of 15

1852 Stone Dwelling. East Elevation

The front of the building faces east and exhibits a front-facing gable and a three bay facade. Six wooden, double-hung, six over six windows with wooden lintels, one in the front gable, three on the second floor, and two on the first floor, surround a centrally located small entry porch with stone steps. The front entry also exhibits a wooden lintel while the door exhibits a window in the upper portion and two panels in the lower portion. A metal screen door has been added to this opening. Two double-hung basement windows flank this entryway.

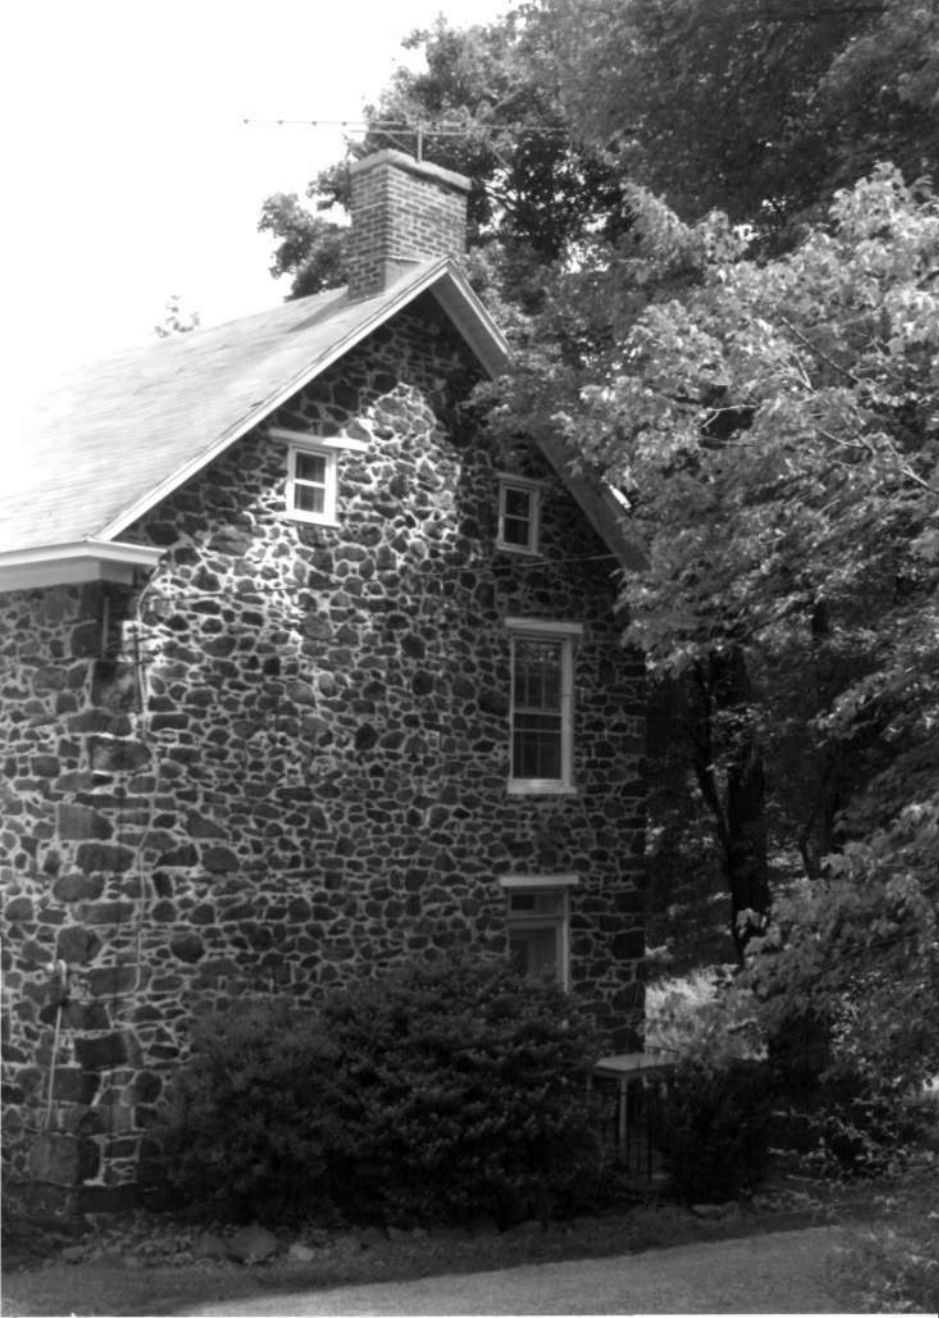
#2 of 15

1852 Stone Dwelling. South Elevation

The southern gable facade exhibits a single full-sized, wooden, double-hung, six over six window on the second floor on the eastern end of the facade and a first floor doorway beneath. In addition, two smaller, double-hung, two over two, windows are present at the attic level, one on either side of the mortared brick chimney, which is centrally located but, with the exception of the portion above the roof, is not visible on the exterior.

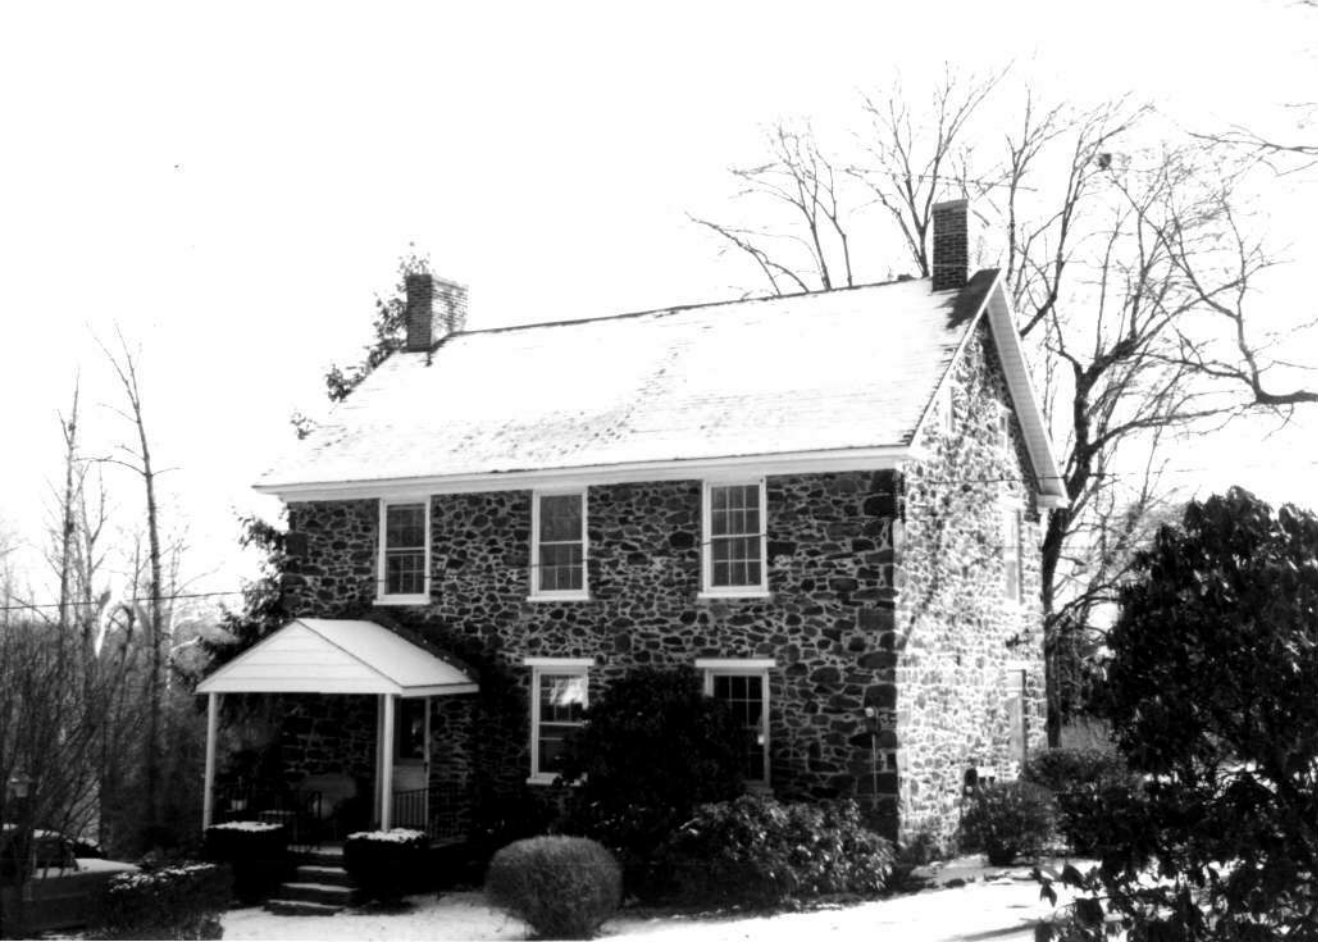
# 3 of 15

1852 Stone Dwelling, West Elevation

The rear of the building also exhibits a three bay facade. There are five wooden, double-hung, six over six windows but the doorway on this facade is located on the northern end of the structure. It is reached by means of a small gable-roofed, wood-columned porch with concrete steps, painted wooden decking, and metal railings. The porch appears to be a late 20<sup>th</sup> century addition.

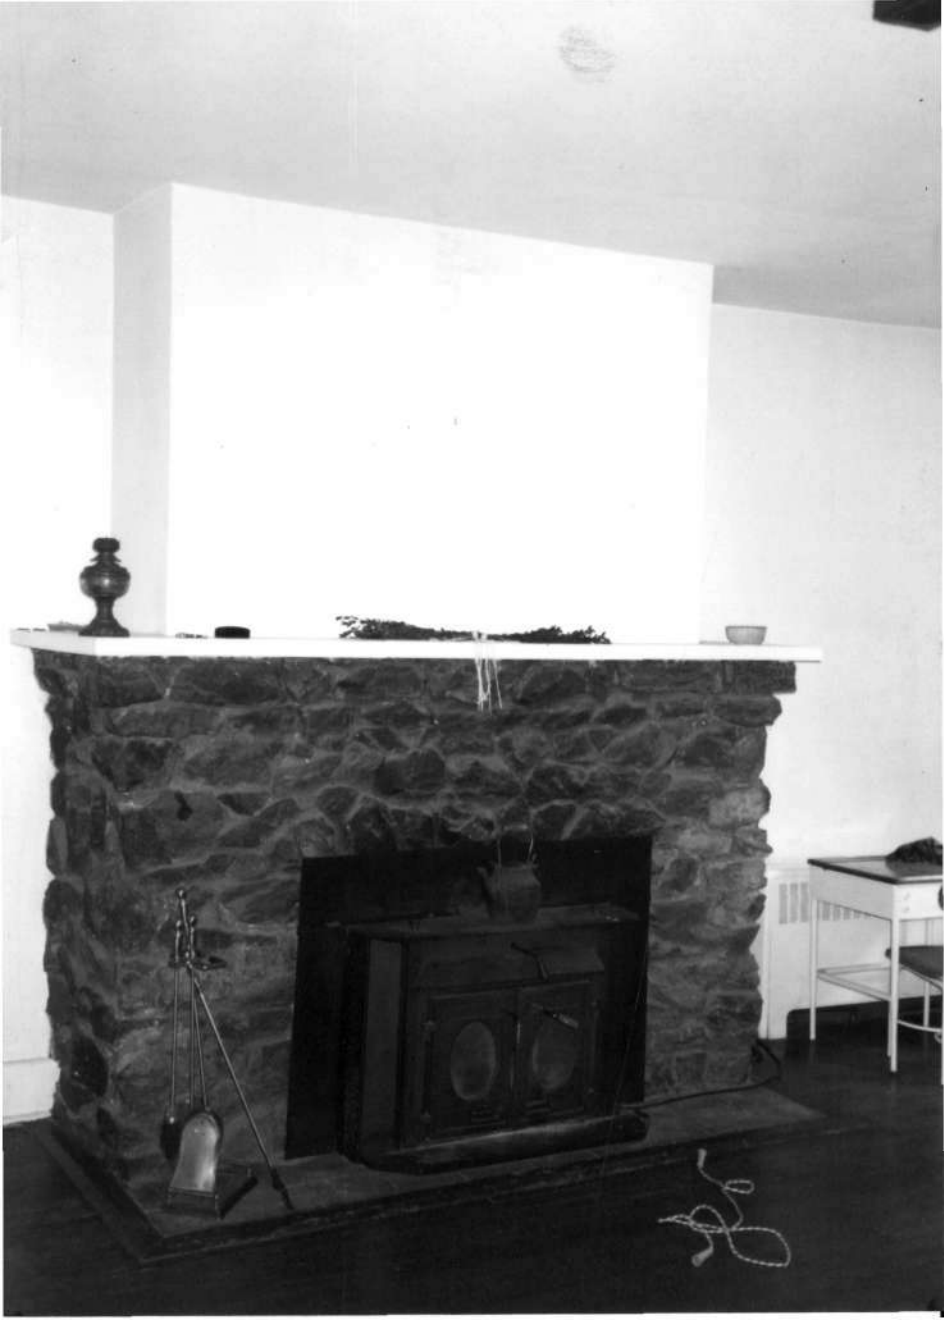
# 4 of 15

1852 Stone Dwelling. Fire place in  
South Parlor. View SW.

A second room runs along the southern side of the house with a centrally located fireplace on the southern wall similar to the one in the other room. Again, the wall and ceiling appear to be plaster and lath while the floor is carpeted.

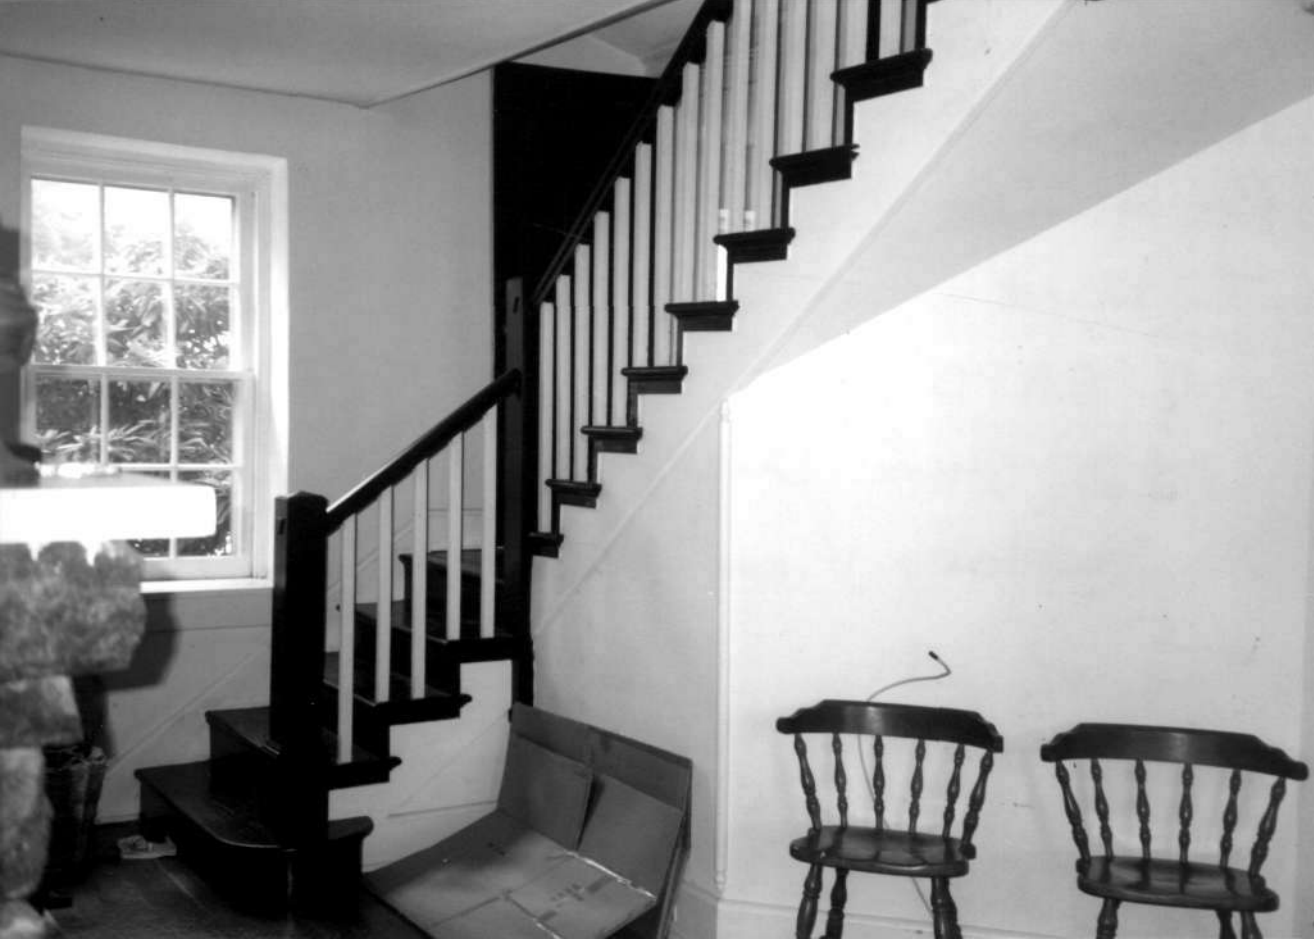
\* 5 of 15

1852 Stone Dwelling. Stairway.

S. Parlor. View West.

The stairs are hardwood with stained and finished treads and painted risers. The banister is also stained while the railings are painted. As previously noted shorts sets of stairs lead to a landing from either the kitchen or living room. At the top of the stairs is a hallway. In the central portion of the front of the second floor is a bathroom with cast iron/enamelled appliances and lavender and white tiles. To the south is a room similar to the living room. This room exhibits a fireplace which appears to have been slightly enclosed, narrowing the opening to about half the downstairs fireplaces. The mantle is wooden. Flooring is 3-inch wide hardwood.

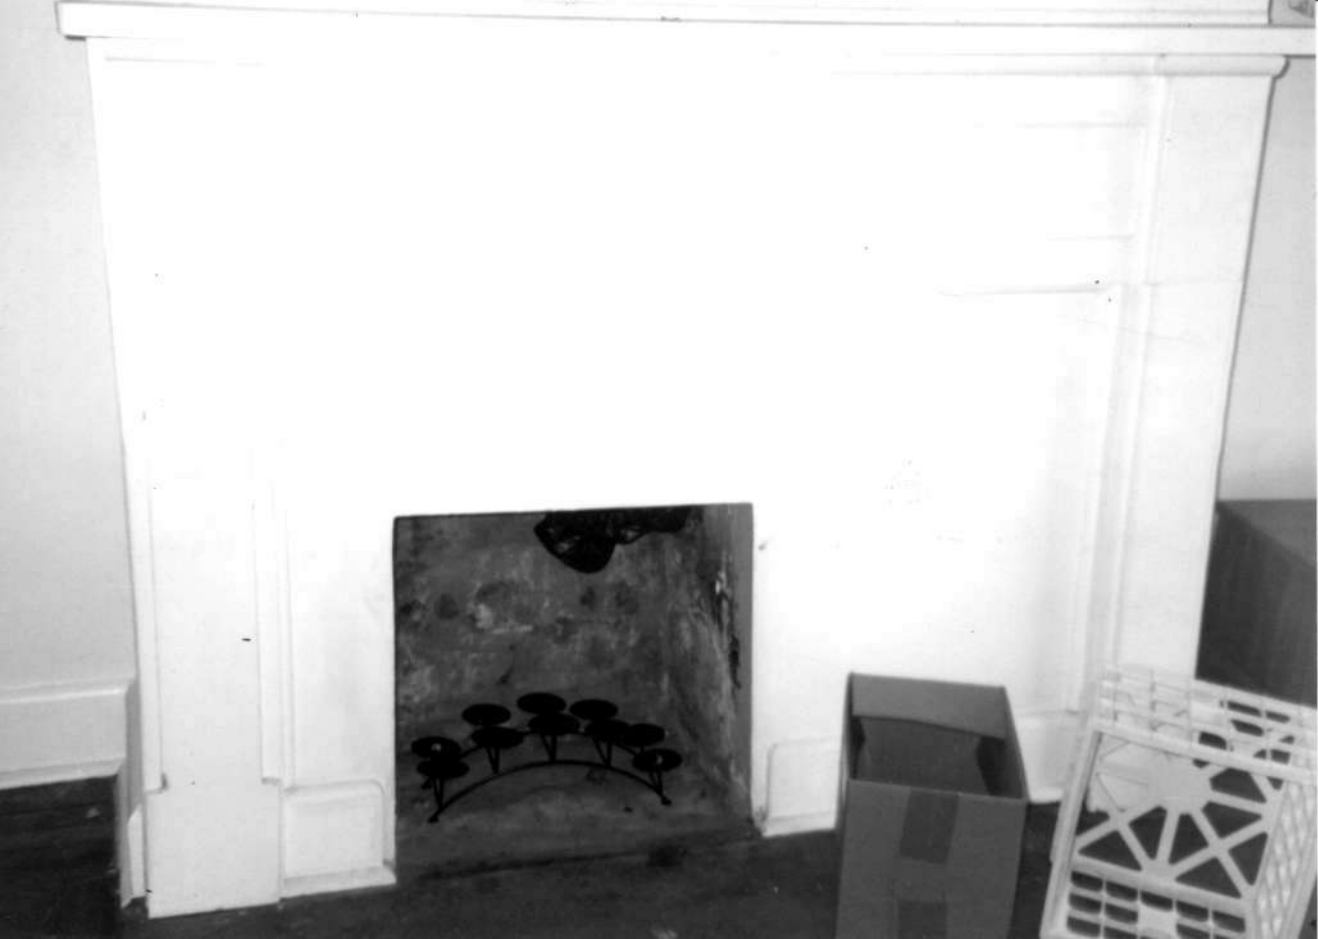
#6 of 15

1852 Stone Dwelling. Fireplace.

South Bedroom. 2ND Floor. View  
South.

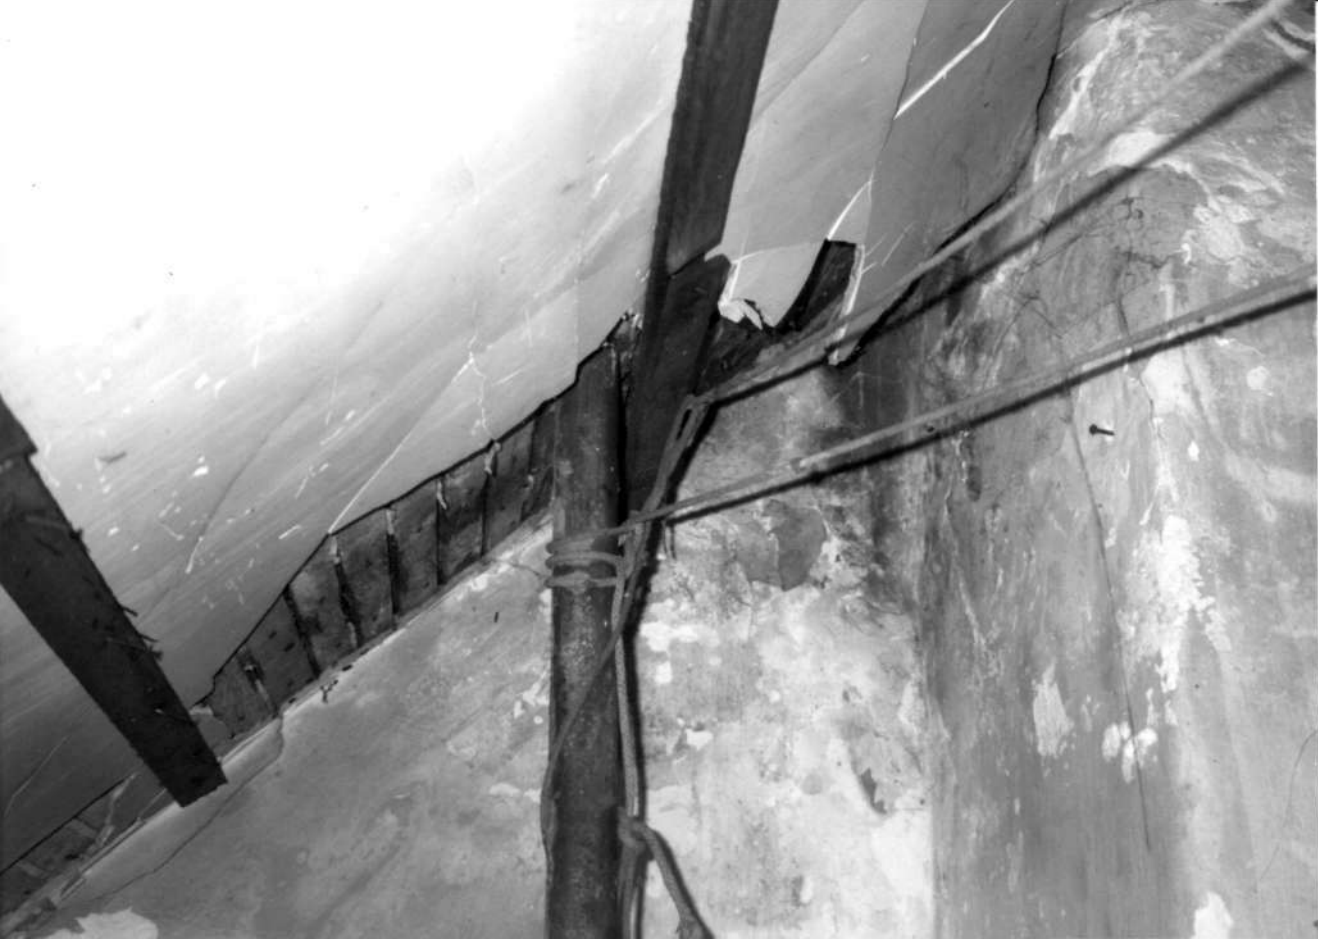
# 7 of 15

1852 Stone Dwelling. Attic. NE  
Corner

The hall on the second floor leads from the top of the stairs to the west between the stairs and the two smaller bedrooms. Here a door leads to the attic. The attic itself is divided into four separate rooms, one in the front facing gable, and all relatively small with slanting ceilings due to the roof line. The plaster and lath finishing present throughout the rest of the house is evident here as well primarily due to its failure along the northern and eastern sides of the building. There appears to be a structural problem with the roof in this area and leakage is causing peeling and cracking of the plaster. Some areas have been patched with corrugated cardboard. The flooring of the attic is 3-inch wide hardwood.

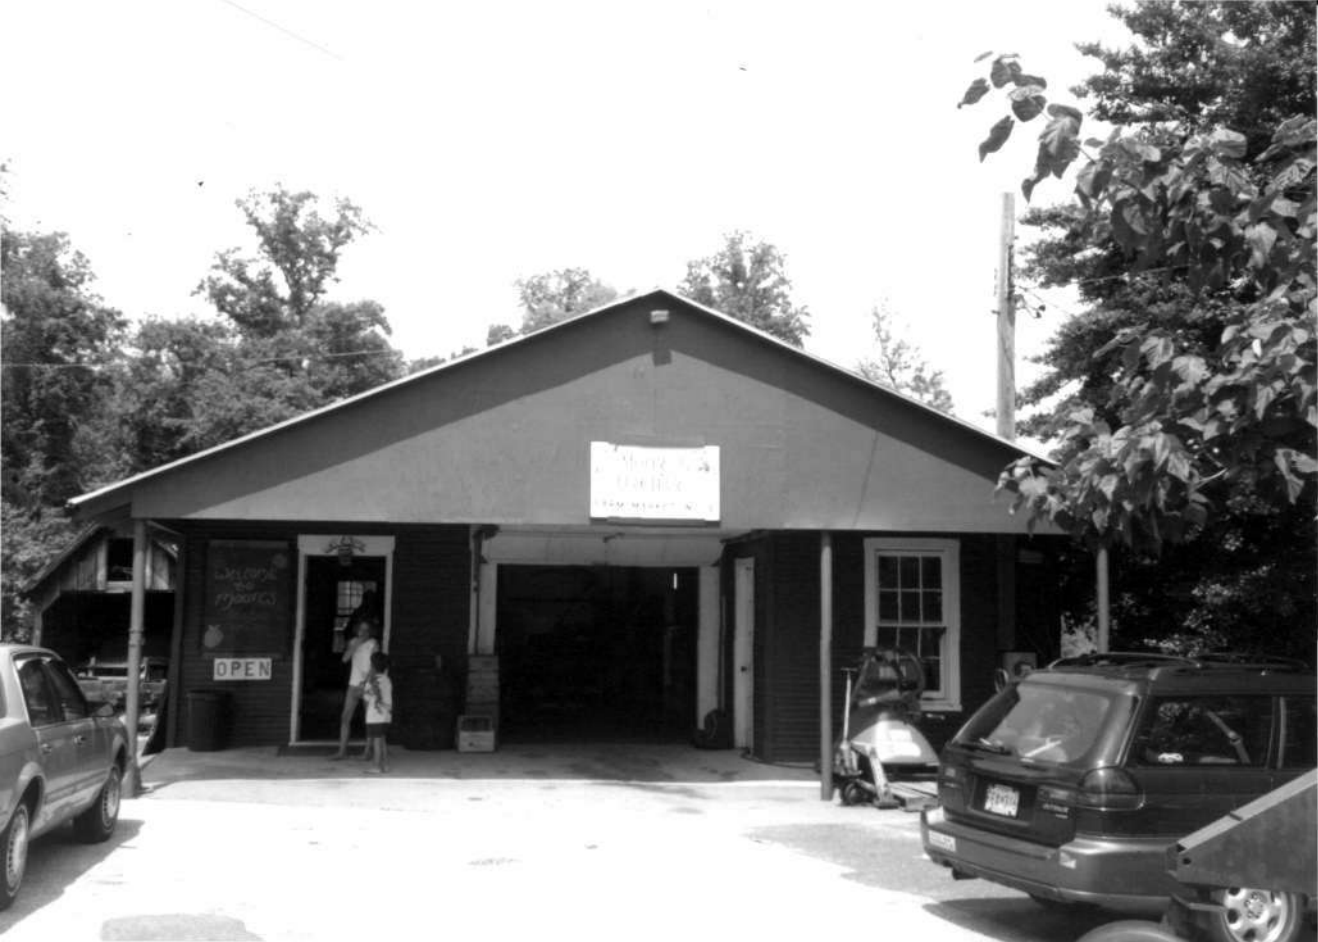
#8 of 15

Farm Store, South Elevation.

The house is reached from Joppa Road by a relatively long, paved drive which leads to the rear of the house, two garages, and a farm store. The farm store is located north and west of the dwelling and measures 30 by 70 feet. The foundation is concrete block and forms a full basement with drive-in entry from the north. The structure is a one-story frame structure, painted red, with a gabled, metal roof. The north and south facade are three bays with wooden double-hung, six over six windows. The southern facade, which is the entrance to the selling floor, is on the same level as the first floor of the dwelling and has a garage-type opening facing south flanked by a doorway to the left. A small, enclosed room is located east of the doorway but under the existing roof. This room has a double-hung, six over six window facing south. The northern facade is two bays with wooden, double-hung, six over six window. A small square window is located in the attic, under the gable. The interior of the store is entirely unfinished. Unfinished shelving and tables line the walls to display fruit and other stock.

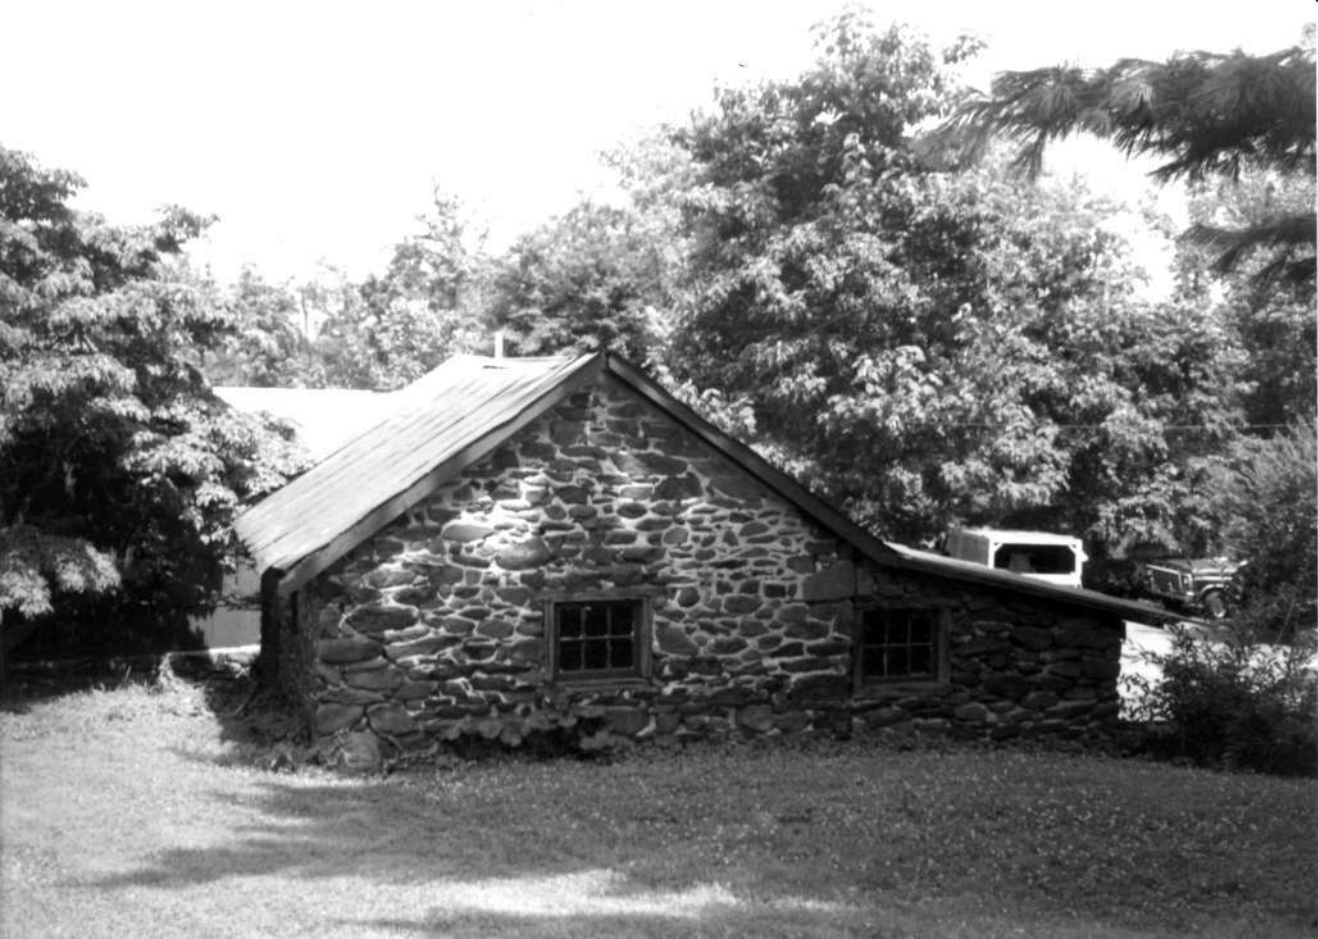
#9 of 15

1st Garage. South Elevation

Just west of the store is a garage/farm shed. This is a banked one-story frame structure, painted red, with a gabled metal roof, and a mortared sandstone foundation. The building measures 25 by 30 feet. The eastern, or front facade consists of hinged, double doors which produce an opening large enough for a tractor or car. There are no windows or ornamentation of any type. The floor is concrete. There is shelving on three sides. The owner stated that the structure was built during the early 20<sup>th</sup> century.

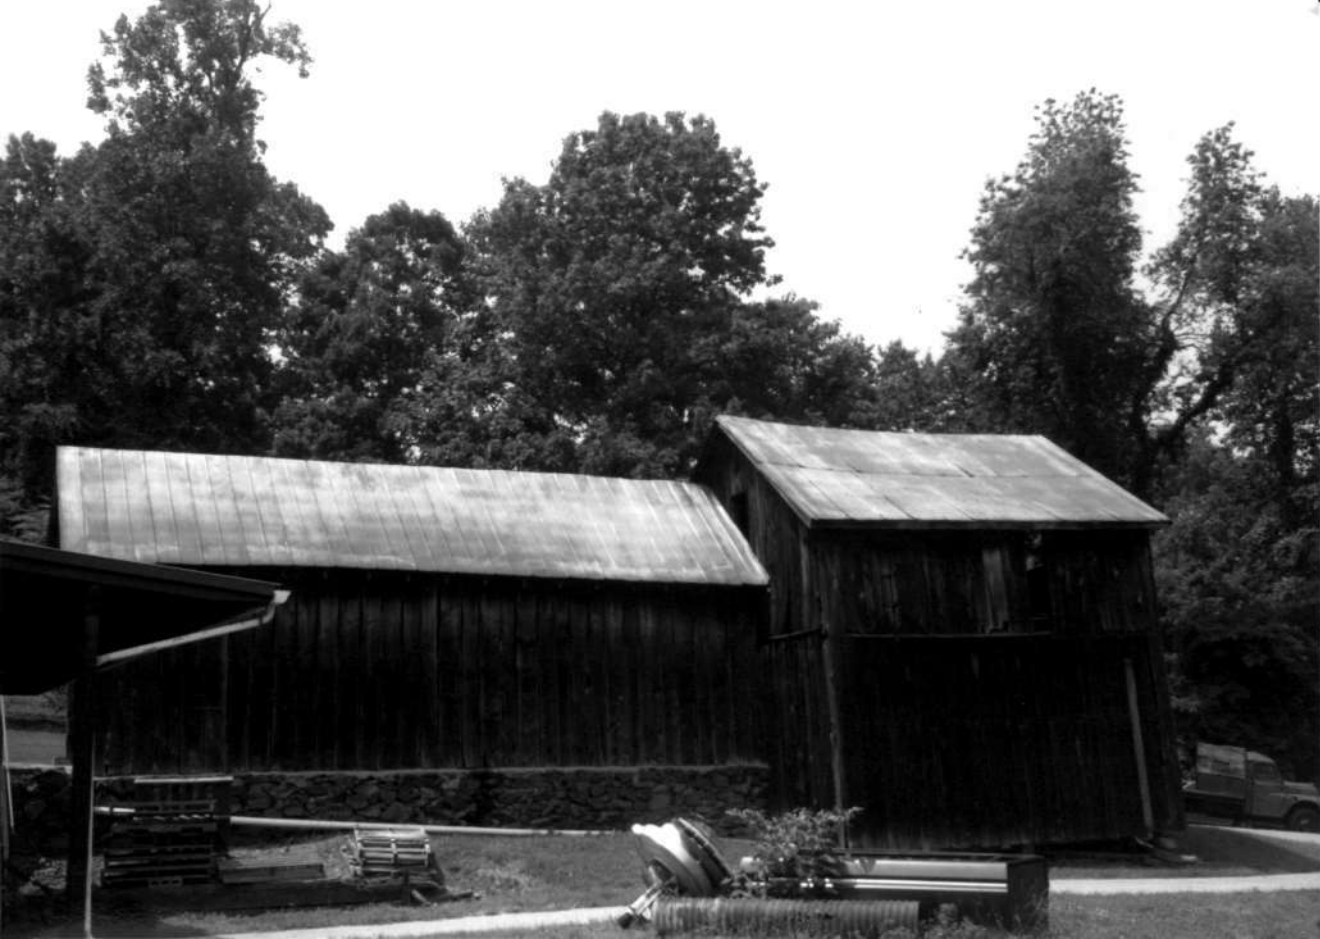
# 11 of 15

Attached Barns . View East.

The farm lane continues to the north between the store and the larger of the two garages. To the east side of the road, directly to the rear of the farm store is a large farm shed which is timber-framed and vertical board-sided. The structure appears to be two buildings joined together. The roofs are gabled metal. The southernmost of the two joined structures measures 10 by 40 feet and is a single story. It rests on a mortared, sandstone foundation. There is a garage door-sized opening in the southern facade with a window sized opening in the gable above it. No door was present. The northernmost of the two structures measures 25 by 25 feet and is a story and a half. It appears to rest on a poured concrete footing on its western side and sandstone footers on the eastern side. A garage door-sized opening is located on the northwest side of the shed. Adjacent to this large doorway is a standard-sized doorway. No doors were present. A window-sized opening was present under the gable.

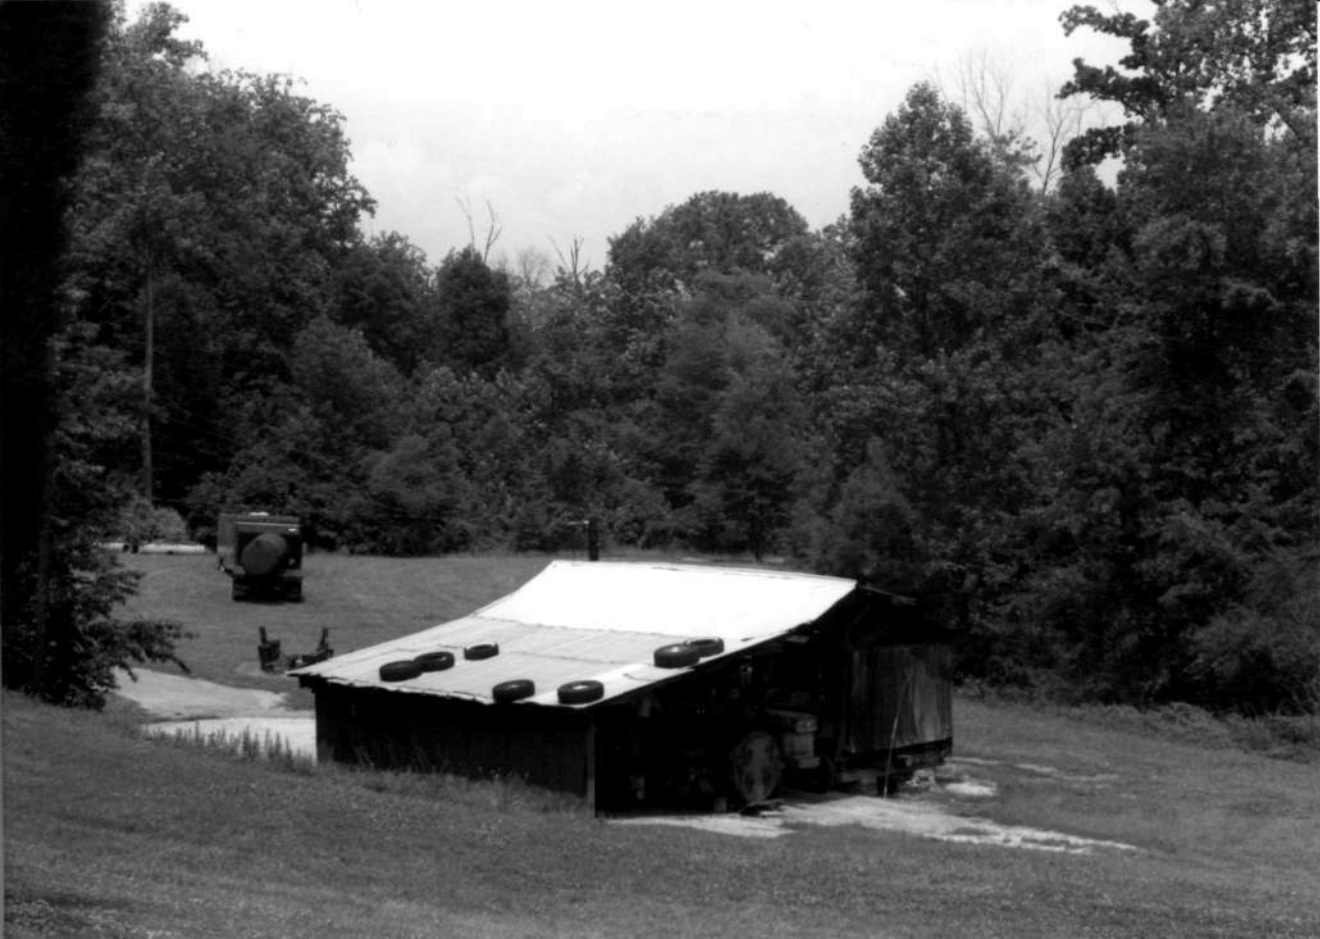
#13 of 15

Shed. View SE

The final farm-related structure is an open-ended, metal-roofed shed with vertical board sides located to the south of the house on a lower terrace. This shed measures 20 by 40 feet and consists of three bays, likely for storing large farm equipment. A small concrete block structure on unknown purpose is located just outside the northwest corner of the shed.

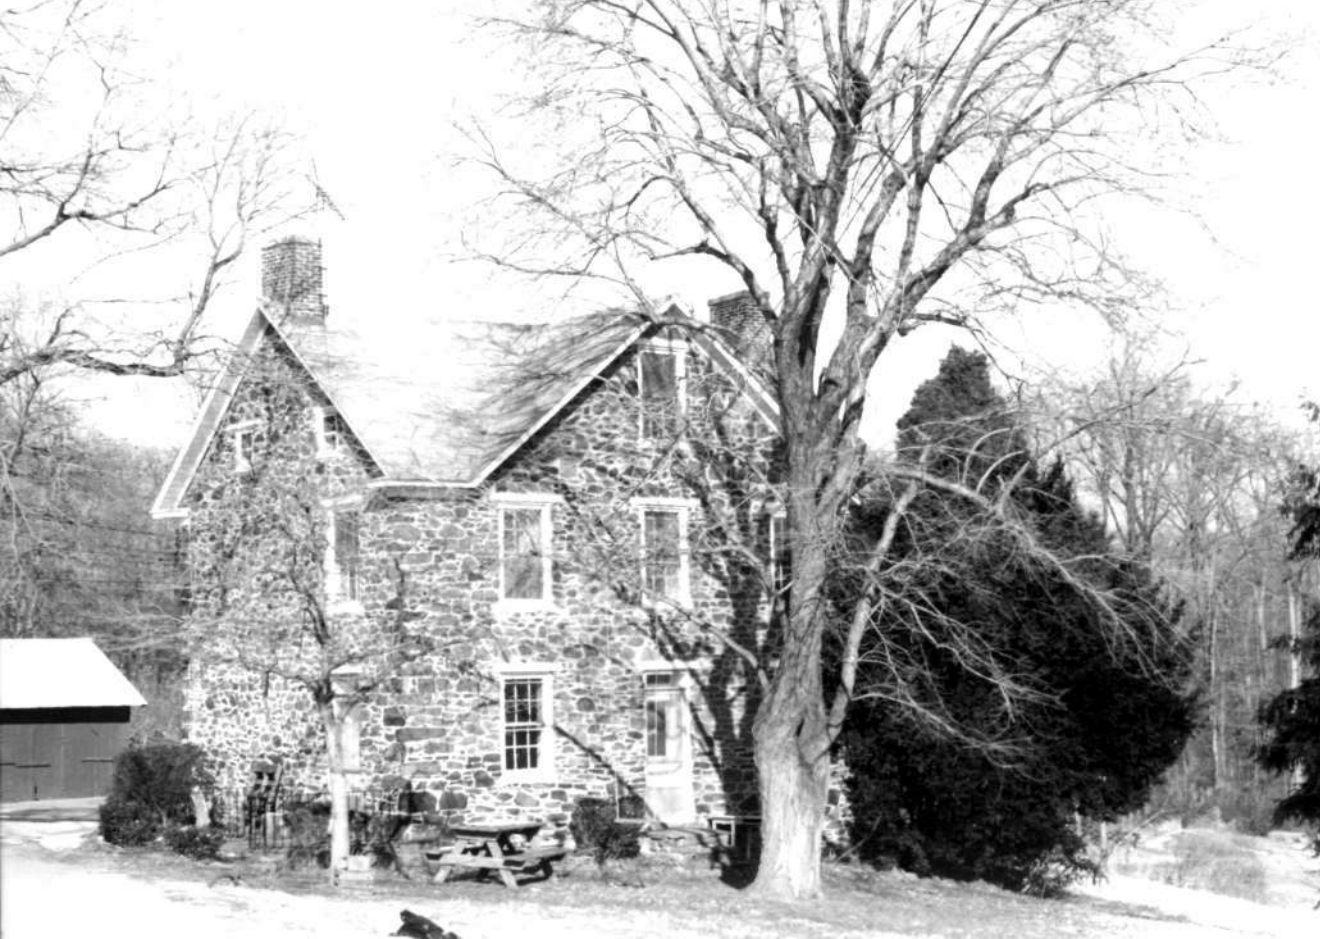
#15 of 15

1852 Stone Dwelling. East Elevation
